Remote Sensing-Based Evaluation of Mangrove Cover Change in Taman Hutan Raya Ngurah Rai, Bali

Annisa Balqis Nurhayati¹ Ni Nyoman Pujianiki^{2*} I Putu Gustave S P³

^{1,2,3}Program Studi Sarjana Teknik Sipil, Universitas Udayana Jl. Raya Kampus Unud, Jimbaran, Kec. Kuta Sel., Kab. Badung, Bali 80361

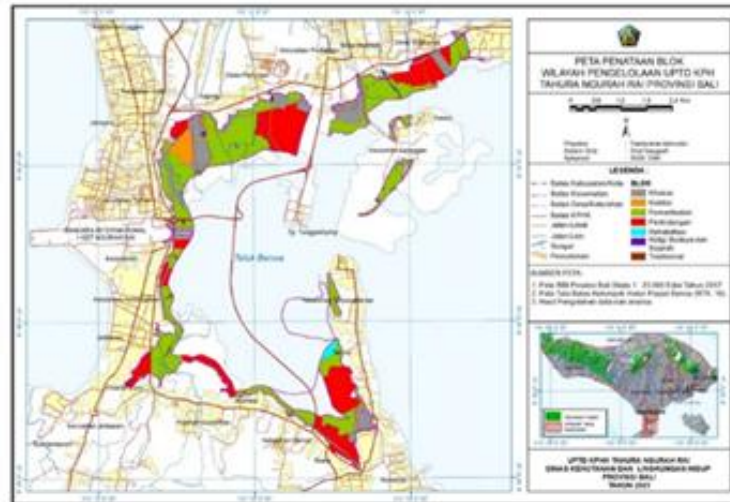
Figure 1. Management Area Block Arrangement Map of UPTD TAHURA Ngurah Rai, Bali Province
Source: UPTD TAHURA Ngurah Rai

Indonesia accounts for approximately 23% of the world's total mangrove area, equivalent to around 3.36 million hectares (KLHL, 2021). The largest mangrove area in Bali is located within the Ngurah Rai Taman Hutan Raya (TAHURA), covering approximately 1,253 hectares (Husnayaen et al., 2023). It is located across the regions of Denpasar and Badung. This area plays a pivotal role in conserving coastal ecosystems, mitigating coastal abrasion, and functioning as the estuary for major rivers. Its designation has undergone several changes in status before being officially established as a Taman Hutan Raya in 1992 (Kumparan, 2022). Management of Tahura is carried out by the Ngurah Rai TAHURA Technical Implementation Unit (UPTD), with the area divided into specific zones: special, collection, utilization, rehabilitation, religious-cultural, and traditional, as depicted in Figure 1.
